Re: Monthly Report Summary #2 for South Orange County Reliability Enhancement (SOCRE) Project

South Orange County Reliability Enhancement Project CPUC Site Inspection Form

Project:	South Orange County Reliability Enhancement Project	Date:	12/1/17
Project Proponent:	San Diego Gas & Electric	Report #:	JV-001
Lead Agency:	California Public Utilities Commission	Monitor(s):	Jenny Vick
CPUC PM:	Andrew Barnsdale, Energy Division	AM/PM Weather:	67-70 degrees, sunny
CPUC CM (E & E):	Joe Donaldson	Start/End Time:	0945 to 1145
Project NTP(s):	NTP-1

Project:	South Orange County Reliability Enhancement Project	Date:	12/28/17
Project Proponent:	San Diego Gas & Electric	Report #:	JV-002
Lead Agency:	California Public Utilities Commission	Monitor(s):	Jenny Vick
CPUC PM:	Andrew Barnsdale, Energy Division	AM/PM Weather:	47 to 58 degrees, sunny
CPUC CM (E & E):	Joe Donaldson	Start/End Time:	0700 to 1000
Project NTP(s):	NTP-2

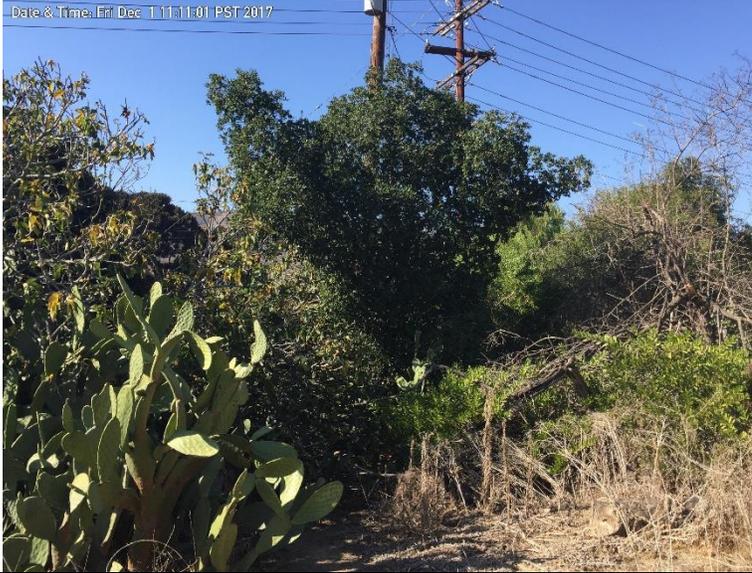
We walked up the hill to the existing Capistrano Substation equipment. We looked at the area where San Diego Gas & Electric (SDG&E) had requested to relocate the perimeter fence under NTP-2 to allow for a larger staging area (Photo 5). I also noted various vegetation that has been proposed for removal under NTP-2, including three coast live oak trees, coastal sage scrub, and prickly-pear cactus (Photos 6 through 8). The prickly-pear cactus habitat was assessed and determined not suitable for coastal cactus wren.

<p>Date & Time: Fri Dec 1 11:11:01 PST 2017</p>	Photo 8 – Direction: west. Prickly-pear cactus and coast live oak tree proposed to be removed under NTP-2.
12/1/17	Capistrano Substation Former Utility Structure, West Wing

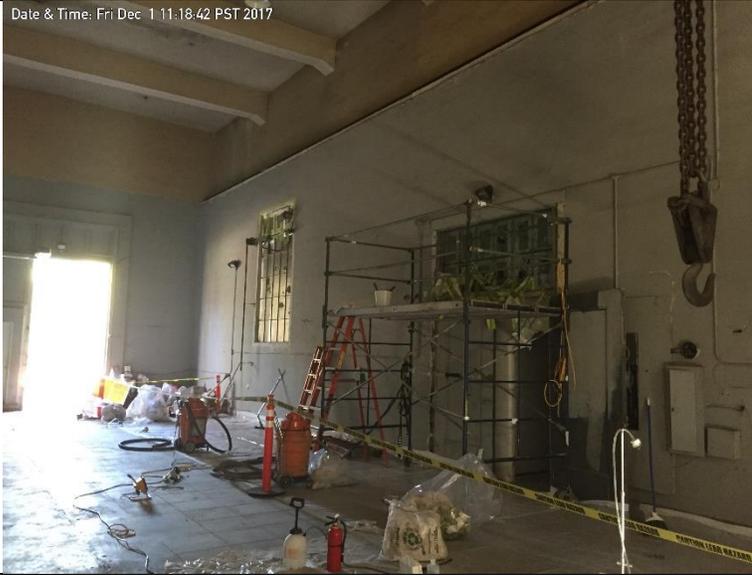
Louie Nunez and I then walked into the former utility structure. He pointed out where the crews were working and the various abatement areas in the structure's west wing (Photo 9).

<p>Date & Time: Fri Dec 1 11:18:42 PST 2017</p>	Photo 9 – Direction: northeast. Abatement activities inside the former utility structure in the west wing.

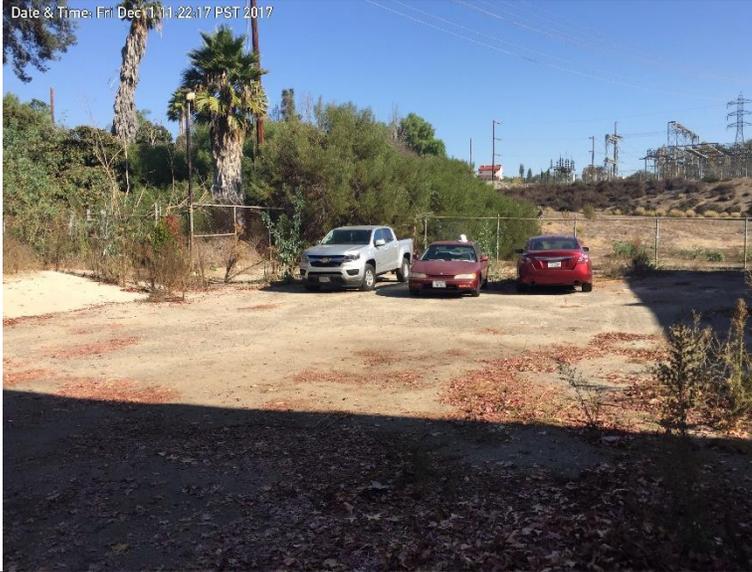
Before leaving the SOCRE Project site, Louie Nunez showed me the paved area where crews had been parking during abatement work (Photo 10).

Photo 10 – Direction: east. Contractor vehicles parked on the pavement north of the former utility structure.

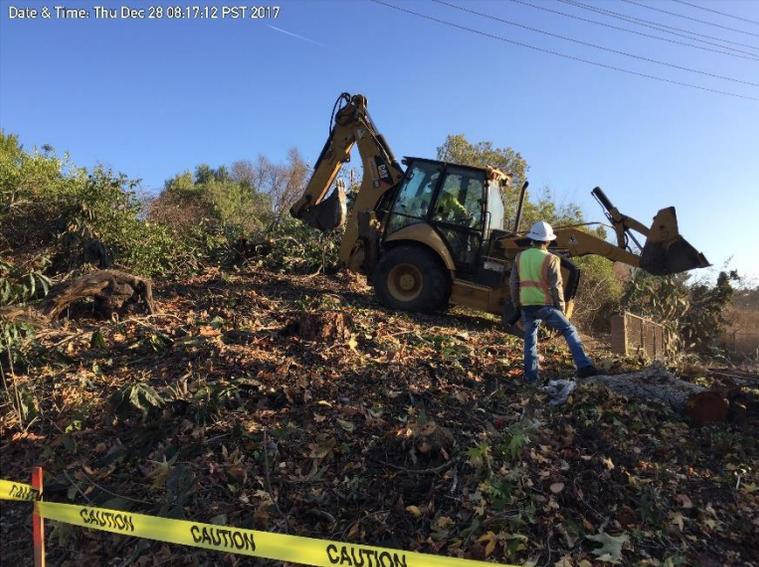
<p>Date & Time: Thu Dec 28 08:17:12 PST 2017</p>	<p>Photo 4 – Direction: east. Cultural resources monitor observing crews removing vegetation.</p>
12/28/17	San Juan Capistrano Substation

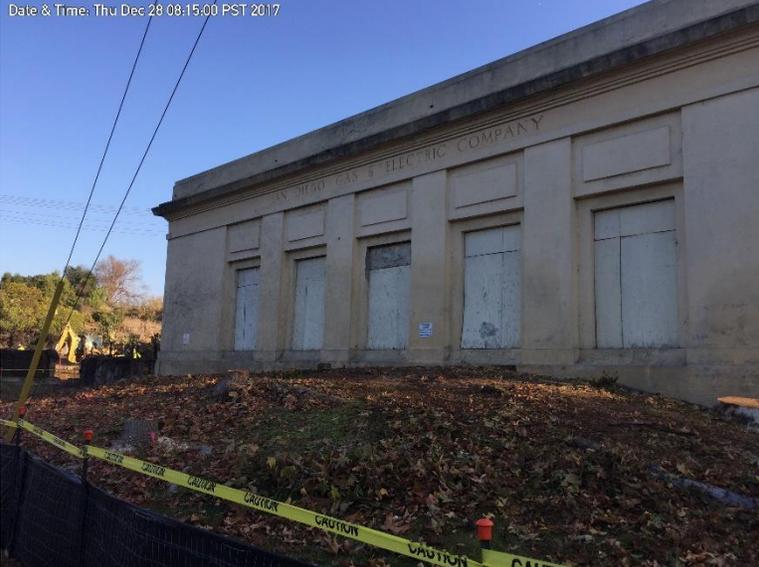
<p>Date & Time: Thu Dec 28 08:15:00 PST 2017</p>	<p>Photo 5 – Direction: northeast. Trees removed from the front of the former utility structure.</p>
12/28/17	San Juan Capistrano Substation

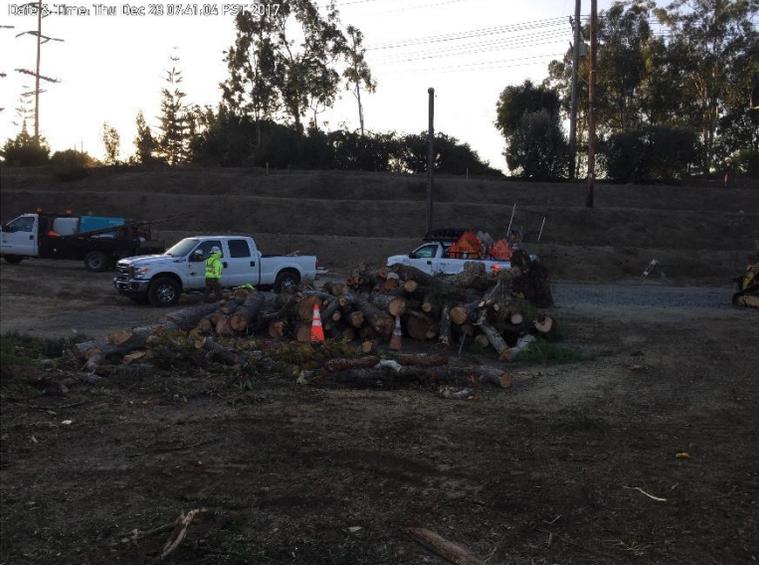
<p>Date & Time: Thu Dec 28 07:41:04 PST 2017</p>	<p>Photo 6 – Direction: south. Stockpiled trees awaiting chipping or removal.</p>

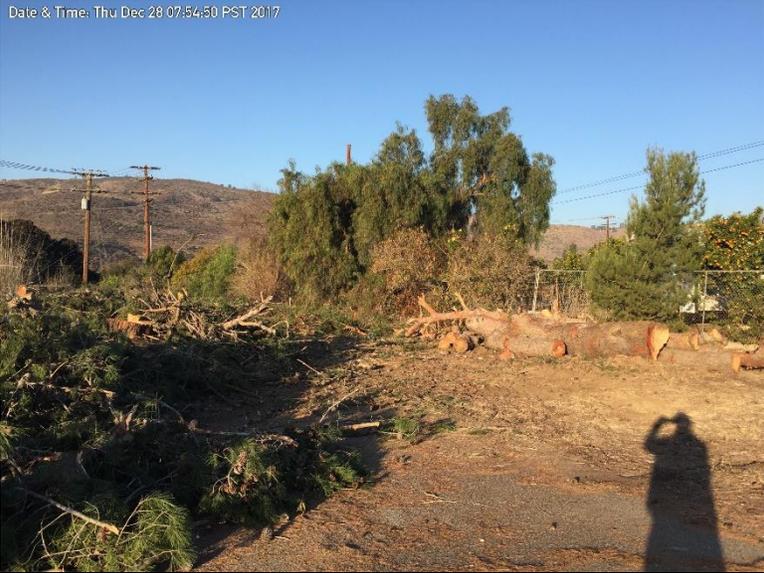
Monitors were onsite, including biological monitor Ford Bendell (ICF), cultural resources monitor Jordan Manvielle (ICF), and Native American monitor Dustin Murphey (Payam Kawichum Kaamalam) (MM BR-2, APM CUL-2, APM CUL-7). Ford Bendell conducted a pre-construction sweep of the work areas prior to the construction activities beginning (MM BR-3). A tree removal crew removed trees in the northeast corner (Photo 2) and southwest corner (Photo 3) of the San Juan Capistrano Substation property. Another crew was working on hand-trimming and removing vegetation with a backhoe in the dense vegetation north of the former utility structure (Photo 4). Earlier in the week, trees had been cleared from the front of the former utility structure (Photo 5) and were piled near a chipper (Photo 6). Vegetation had also been removed in the northern portion of the San Juan Capistrano Substation property and was stockpiled before it was chipped (Photos 7 and 8). No ground disturbance was observed.

Photo 8 – Direction: west. Stockpiled vegetation.
12/28/17	San Juan Capistrano Substation	<p>Date & Time: Thu Dec 28 08:14:11 PST 2017</p>

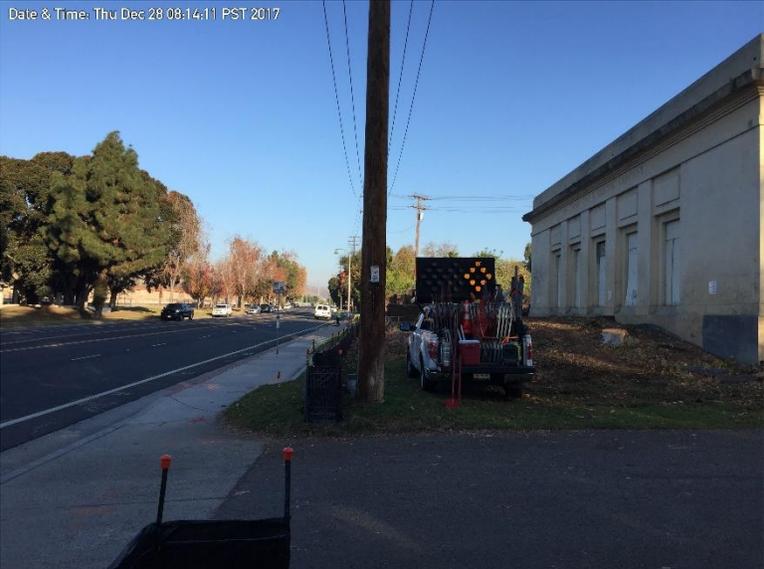
A traffic control truck with lights was onsite to indicate that work was occurring adjacent to the former utility structure (Photo 9). The truck was equipped with signs and cones in the event that any vegetation fell onto the roadway or sidewalk. A crew member was actively sweeping the sidewalks and gutters to ensure the path was clear for pedestrians (APM AES-1) (Photo 10).

Photo 9 – Direction: north. Traffic control truck onsite and prepared to set up signs or cones if vegetation falls onto the roadway or sidewalk.

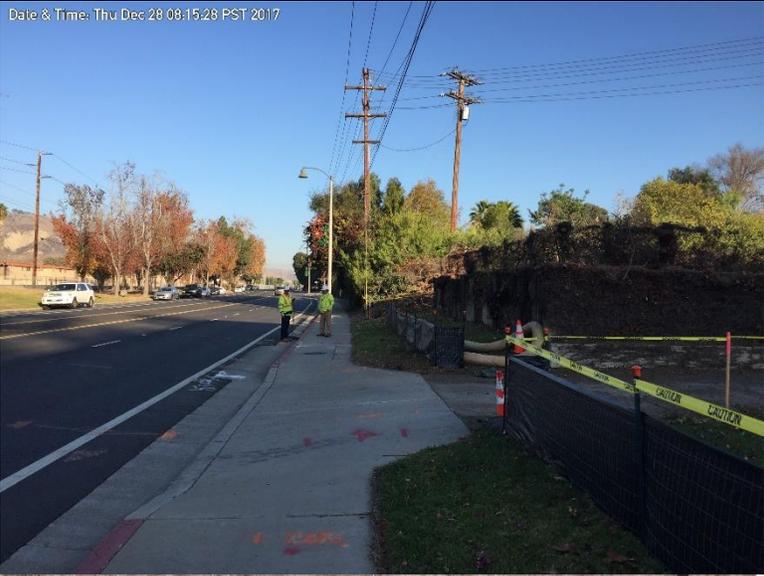
<p>Photo 10 – Direction: north. Crew member sweeping the gutter and sidewalks.</p>
12/28/17	San Juan Capistrano Substation	<p>Date & Time: Thu Dec 28 08:30:54 PST 2017</p>

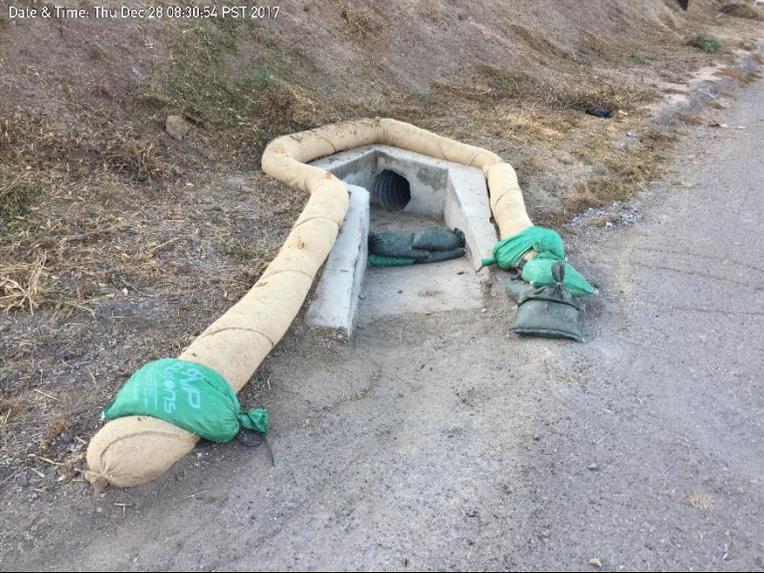
Best management practices (BMPs) were installed around one drain onsite (Photo 11). Prior to South Orange County Reliability Enhancement (SOCRE) Project construction activities, gravel bags had been placed in the drainage below the existing Capistrano Substation. These gravel bags are now degraded (Photo 12) and will be cleared and replaced in the coming weeks.

<p>Photo 11 – Direction: southwest. BMPs installed around a drain.</p>
12/28/17	San Juan Capistrano Substation	<p>Date & Time: Thu Dec 28 08:29:48 PST 2017</p>

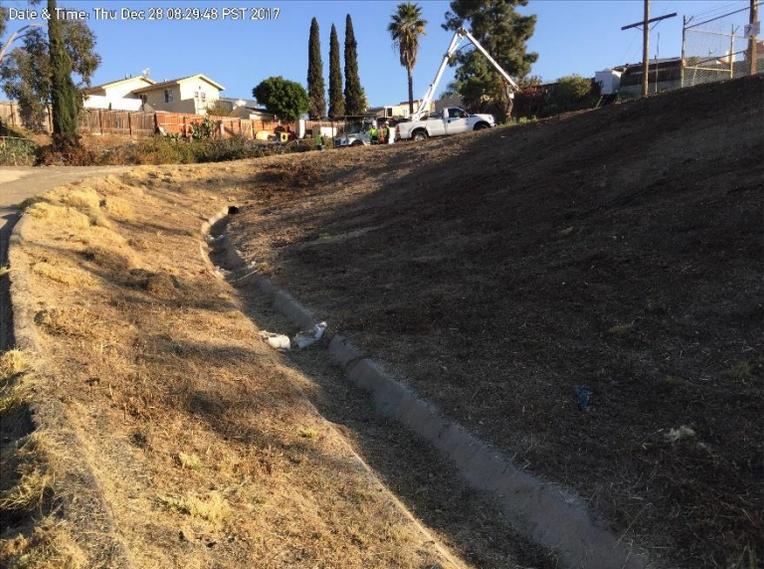
<p>Photo 12 – Direction: northeast. Drainage with degraded gravel bags that were installed prior to the SOCRE Project.</p>
